# LONG-TERM CF6 ENGINE PERFORMANCE DETERIORATION - EVALUATION OF ENGINE S/N 451-479

W. H. Kramer and J. J. Smith

General Electric Company  
Aircraft Engine Group  
Cincinnati, Ohio 45215

Prepared for  
NATIONAL AERONAUTICS AND SPACE ADMINISTRATION  
Lewis Research Center  
Cleveland, Ohio 44135  
February 1978  
Contract NAS3-20631

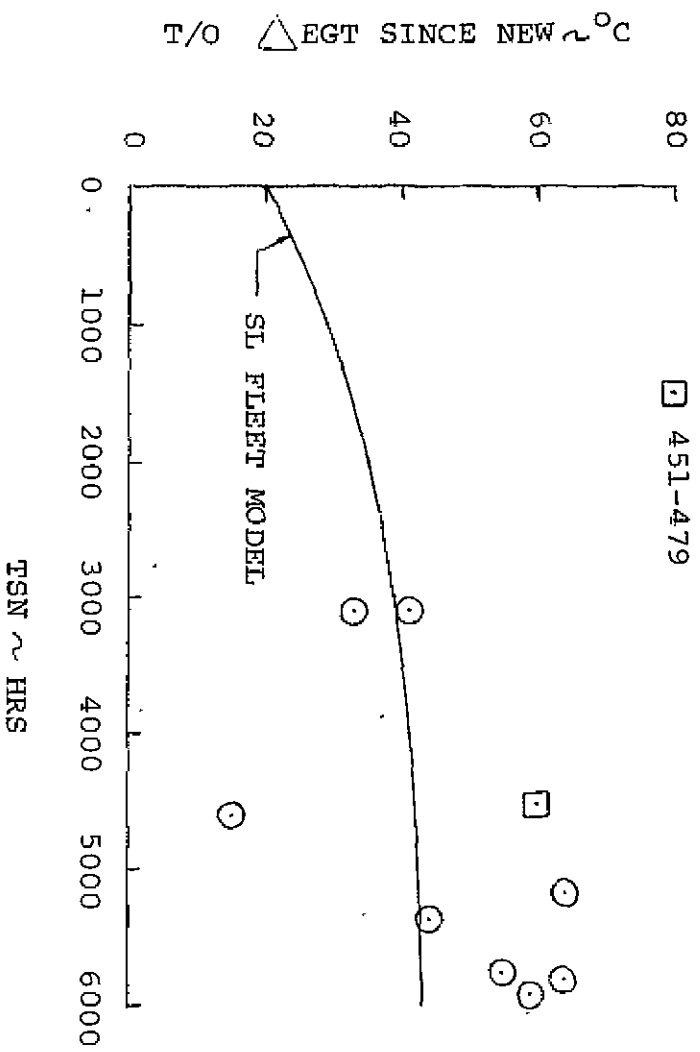
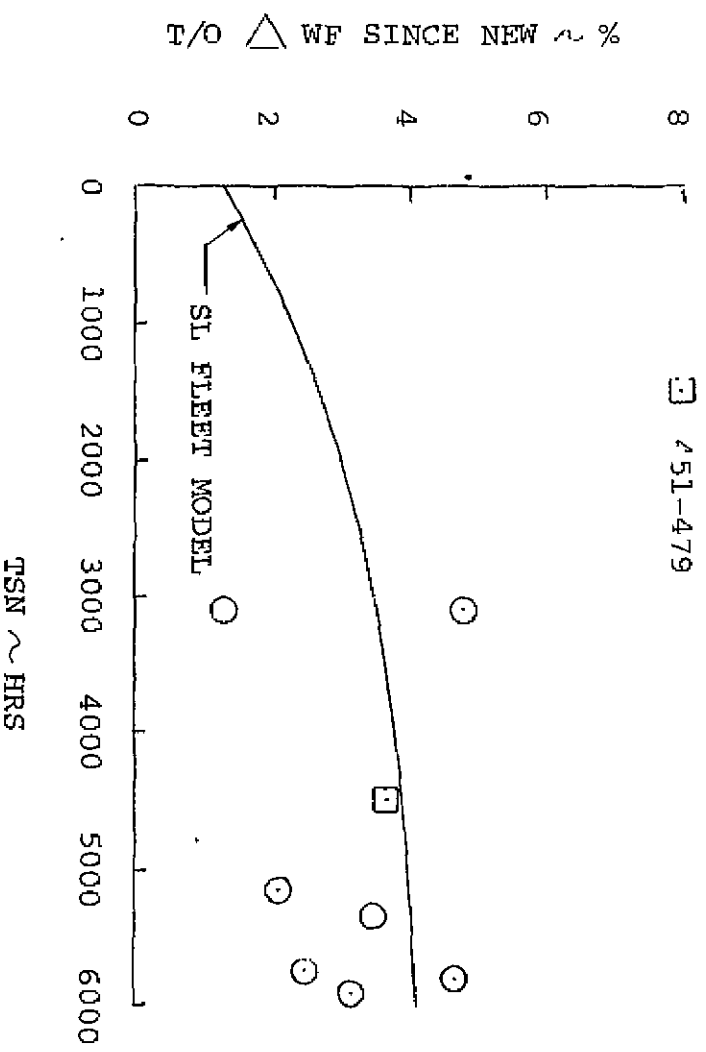
Figure 5-2. CF6-6D Inbound Sea Level Deterioration.

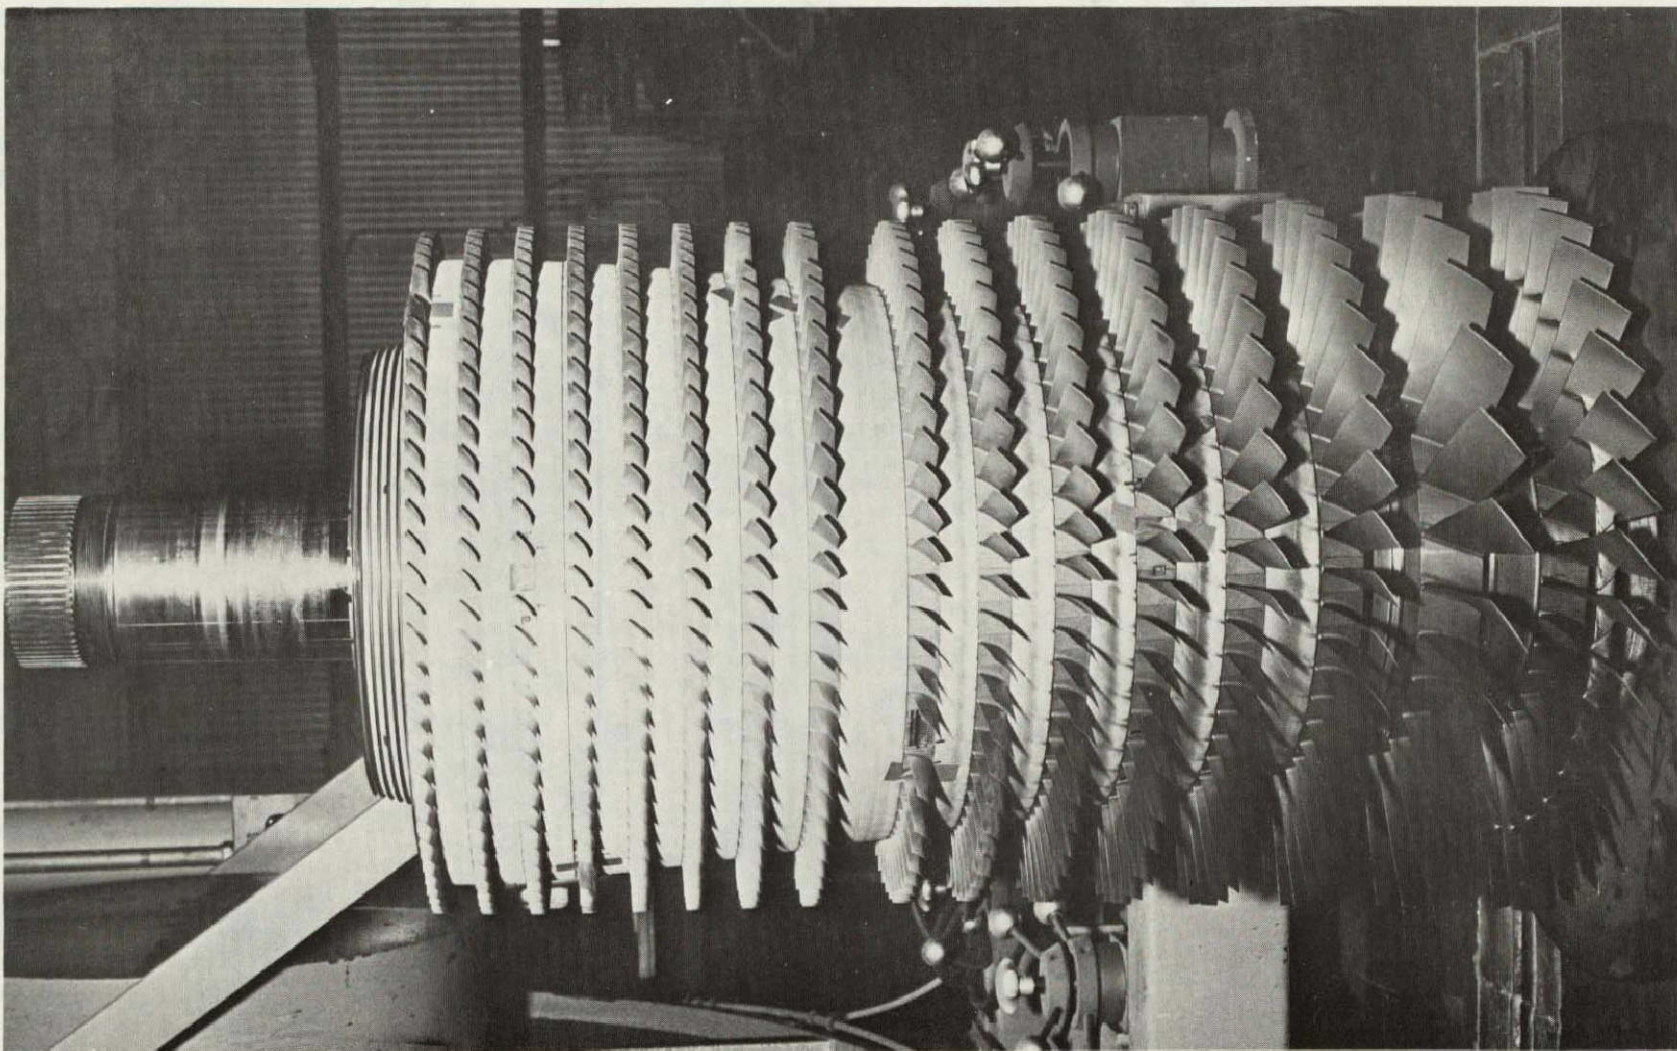
Inspection of the HP compressor rotor revealed the spool and blades to be extremely dirty throughout, with a heavy deposit of oil mixed with the dirt in the forward end (through Stage 6). Some very mild aluminum splatter was noted on blades in Stages 12 and aft. A photograph of the rotor assembly was taken (Figure 8-1); however, it was not taken until after the rotor had been prematurely cleaned, erasing all evidence of the dirty condition.

Figure 8-1. High Pressure Compressor Rotor (Cleaned), Missing Blades  
at Surface Finish Check.

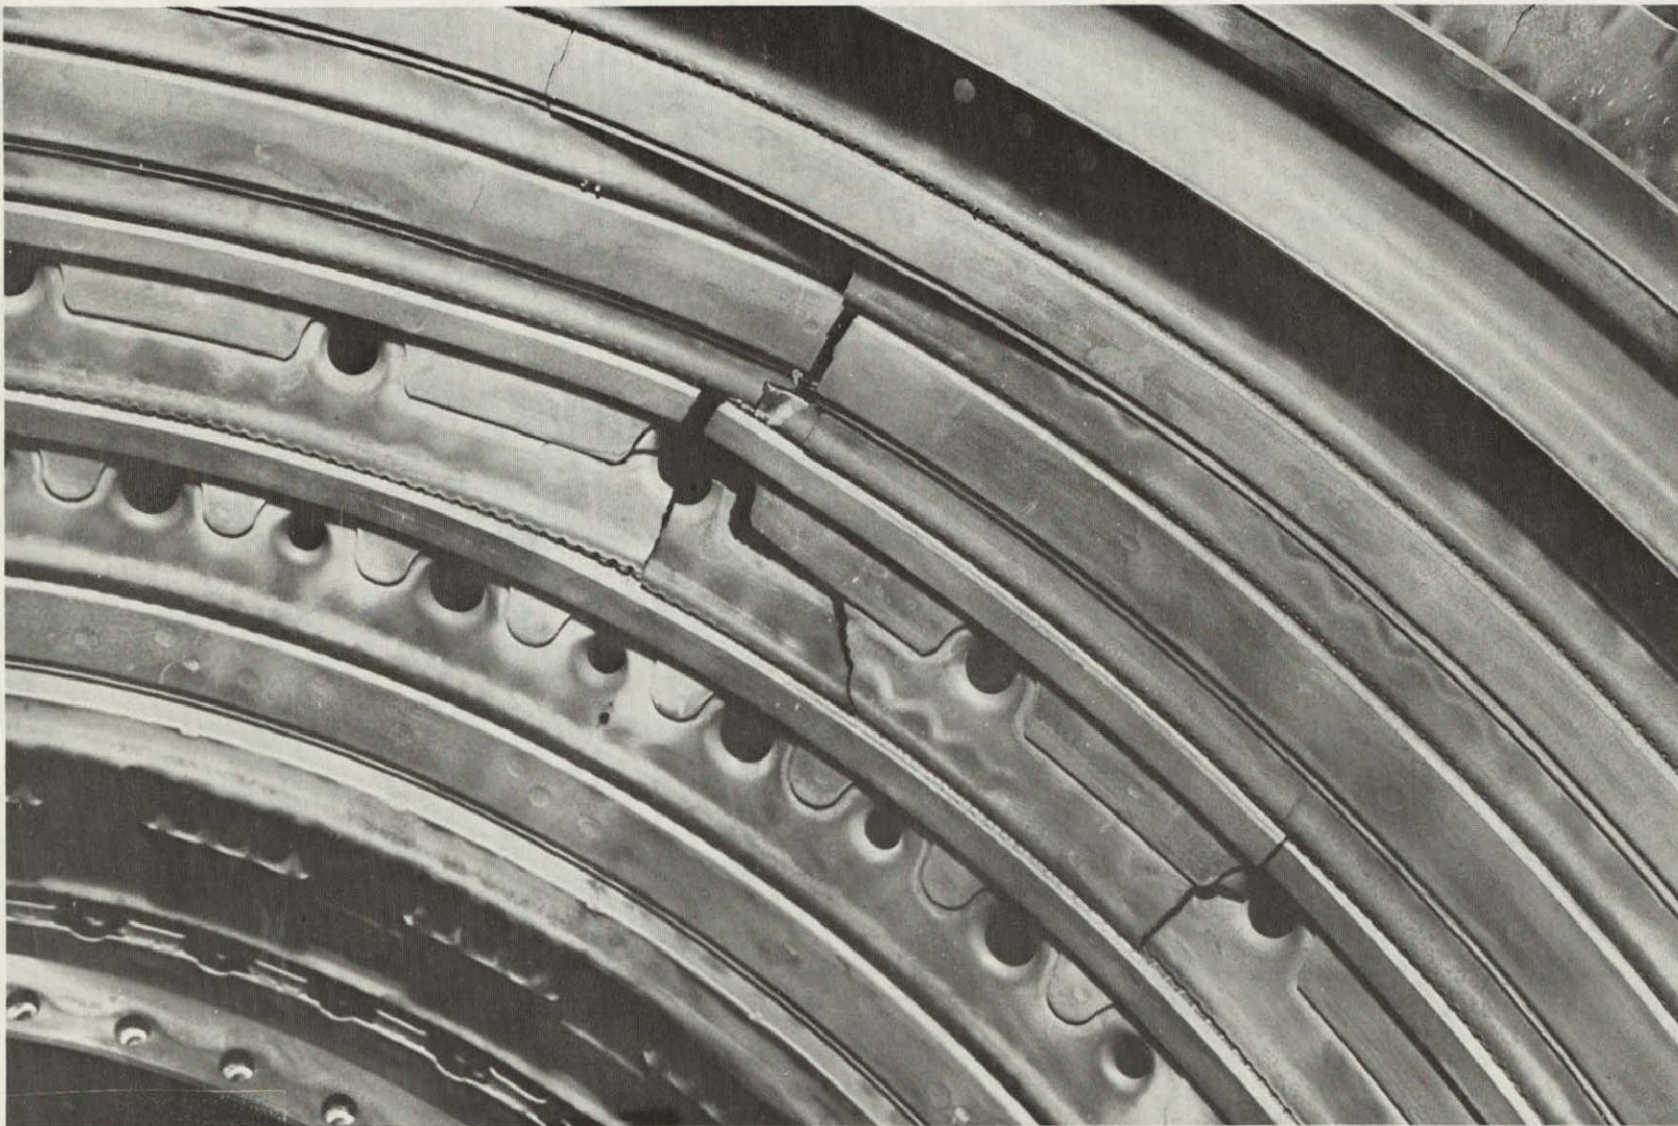
To expedite the work scope, the combustor was not removed from the rear frame, but rather visually inspected as installed. The combustor had its typical 1/4" to 1/2" cracks, inner and outer liners. The most noteworthy fault was the cracks originating at the inner liner's aft thimble louver at approximately the 7 o'clock location. This particular louver had cracked in four different directions of varying lengths (Figures 8-6 and 8-7 in Appendix B). The cracks were approximately 5/8", 1", and 2-1/2" in length and another about 2-1/4" long connecting with a 4-1/2" circumferential crack. The whole piece was bulged into the airstream approximately 5/8". There were six more of these thimble louvers with cracks ranging from 1/2" to 1-1/4" but these are considered insignificant with regard to performance.

Figure 8-7. Combustor, Closeup Crack at 7 o'clock.
